LOCK 3 DAM AT MECHANICVILLE

INVENTORY NO. N.Y. 215

PHASE I INSPECTION REPORT

NATIONAL DAM SAFETY PROGRAM

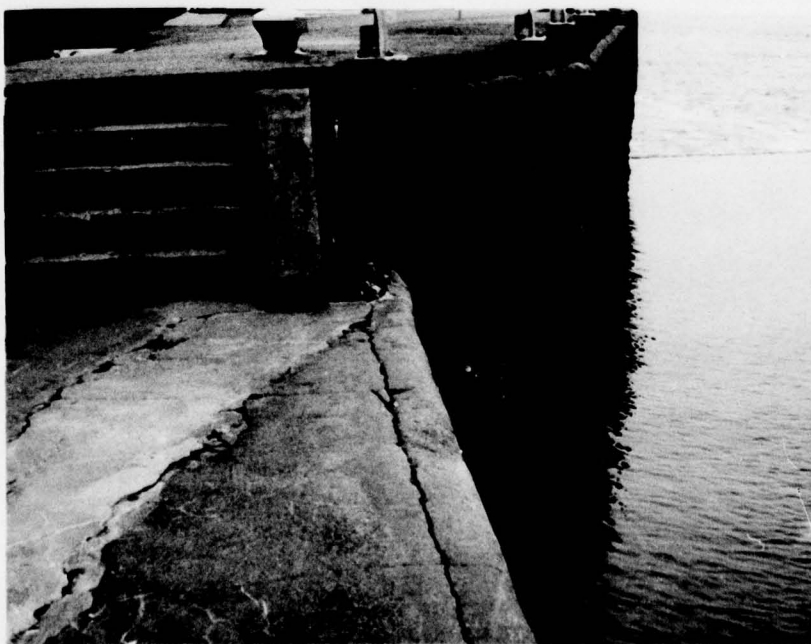
1. Concrete spalling on the river-side face of the lock upstream protection pier.
2. Smaller areas of spalled concrete on the outer lock walls both upstream and downstream of the crest, in the zone of flow aeration.
3. At the spillway-gatehouse contact, seepage through one masonry block horizontal joint immediately adjacent to the crest was observed.

CONCRETE SURFACE DETERIORATION @
LOCK - SPILLWAY CONTACT

- a) Rehabilitate all deteriorated and cracked concrete surfaces.
- b) Remove the trees and brush from the earth dike embankment.
- c) Regrade the top of the earth dike to provide a level embankment crest.
- d) Perform periodic maintenance of the dam and all appurtenant structures.
- e) Develop and implement a detailed emergency-operation plan and warning system.
- f) As a result of the completed additional investigations, remedial measures deemed necessary should be completed within two years of the date of this report.

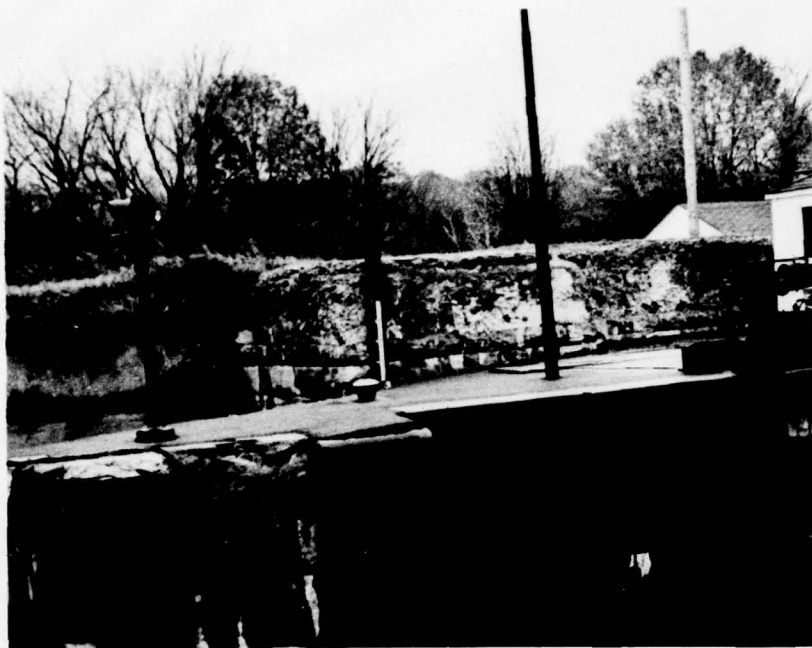
1. The concrete surfacing on the Lock-earth dike masonry abutment was deteriorated considerably; having aggregate exposed and surface corners well-rounded from weathering.

CONCRETE DETERIORATION @ ABUTMENT
OF EARTH DIKE - LOCK 3

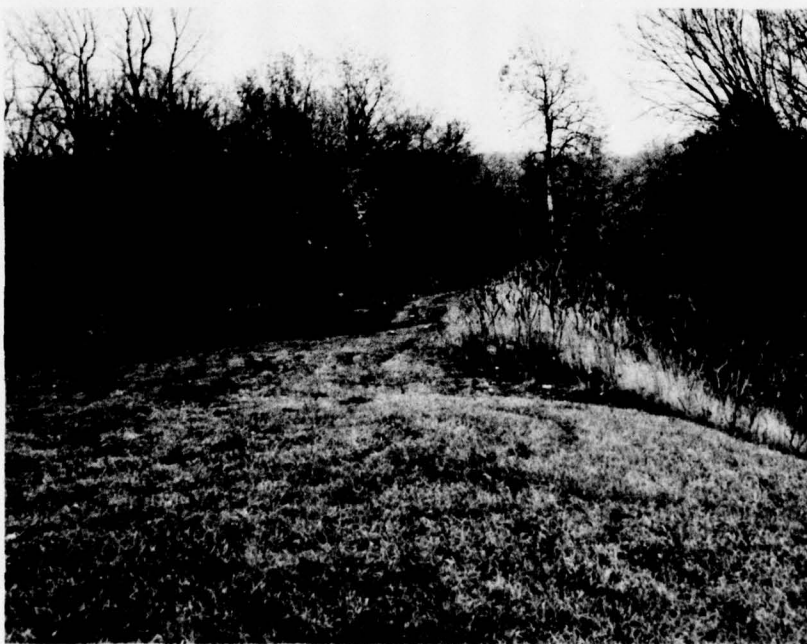
EARTH DIKE

2. The concrete facing on the dike embankment's upstream slope protection was cracked.
3. The vertical alignment of the crest was somewhat irregular sloping downward in the upstream direction; a vehicle path existed on the top of the dike.
4. Several large trees existed on the top of the embankment.
5. Small trees and brush existed on the downstream slope of the embankment.

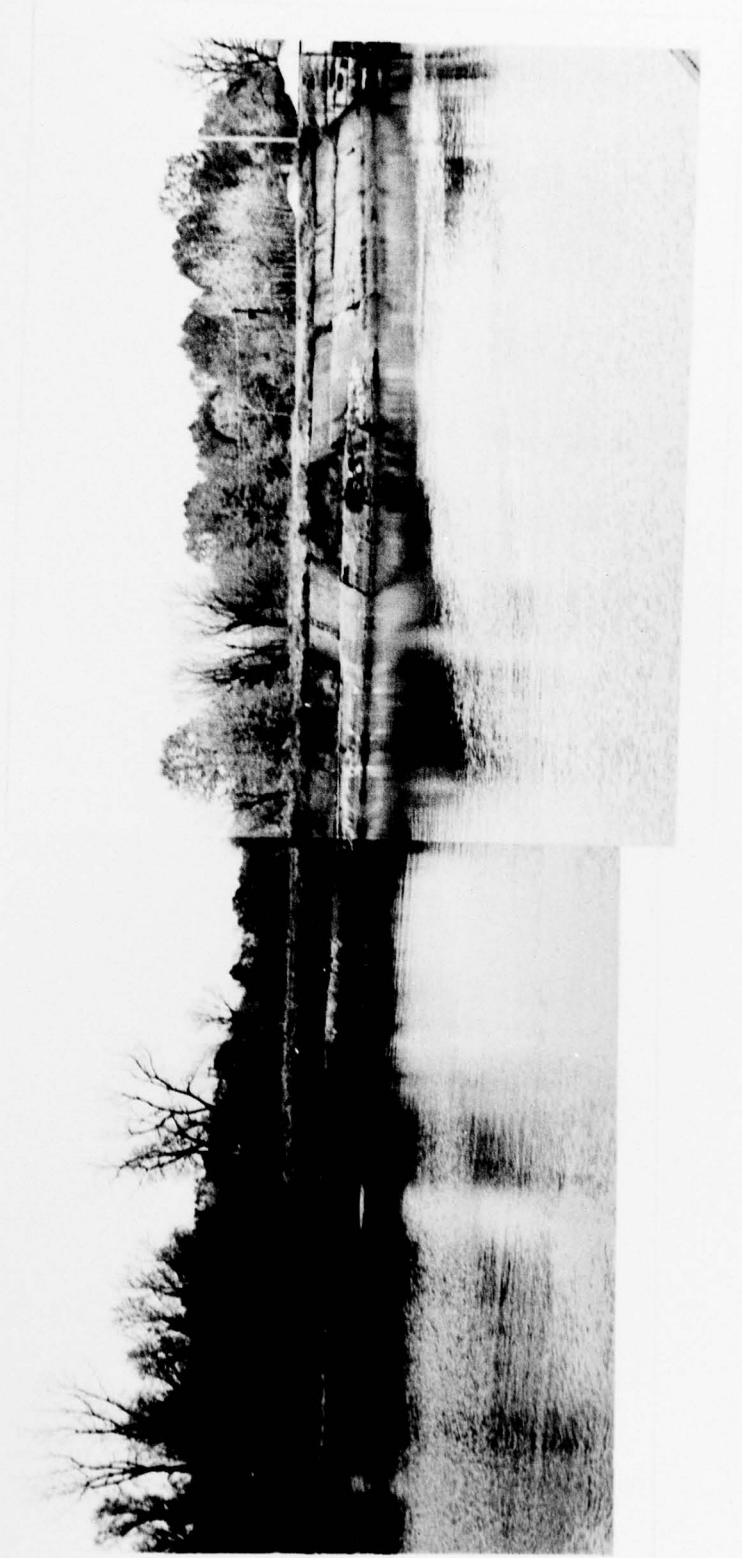
1. The concrete facing on the dike embankment's upstream slope protection was cracked.
2. The vertical alignment of the crest was somewhat irregular sloping downward in the upstream direction; a vehicle path existed on the top of the dike.
3. Several large trees existed on the top of the embankment.
4. Small trees and brush existed on the downstream slope of the embankment.

UPSTREAM SLOPE PROTECTION ON EARTH DIKE

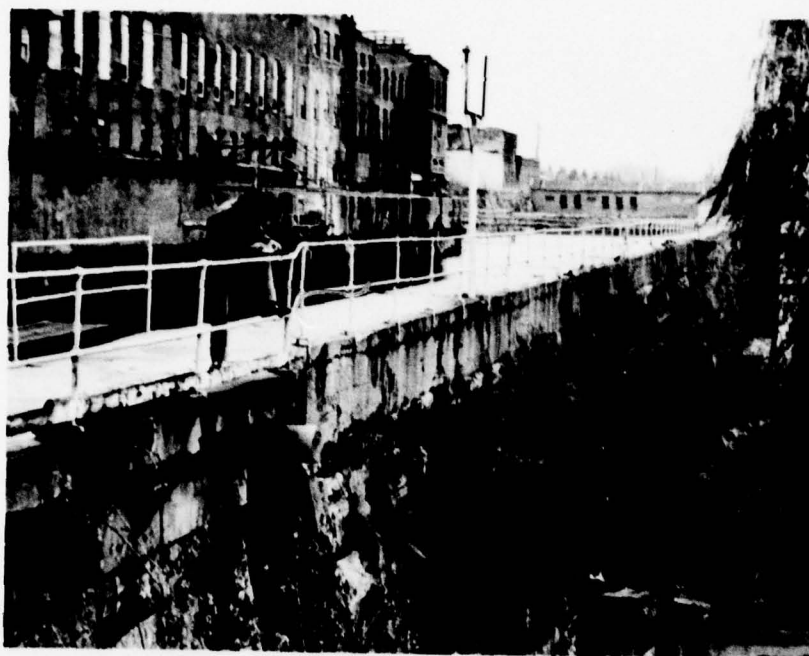
6. Seepage through the east wall was occurring in three areas which were all in excess of 200 feet downstream of the axis of the dam.
7. Cracked concrete and joint separation in the masonry was evident along much of the east wall.

OUTER FOREBAY WALL
(GATEHOUSE - BACKGROUND CENTER)

Operation and maintenance of the Lock is satisfactory. Additional maintenance is needed to remedy the earth dike deficiencies stated above. In addition, all masonry and concrete structures including the gatehouse-forebay should be repaired as necessary.
